Manhole Inspection Summary

Manhole # S55S__004MH

Insp Date: **3/17/09 8:14 AM**

Location Address: **1516 S HIGHLAND AV**

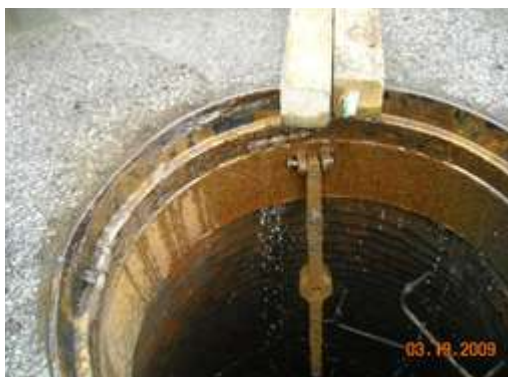
MISC.

INFLOW EVIDENCE FROM SHEETING

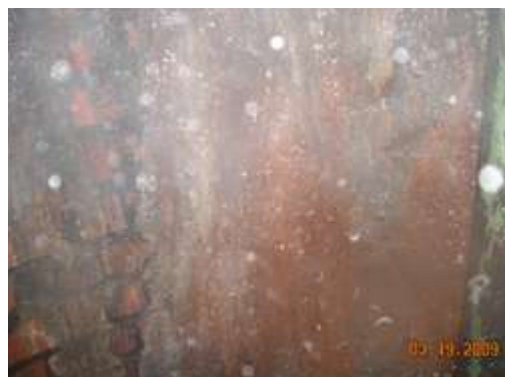
Defect 3

Infiltration: ☐ None ☐ Joint ☐ Cracks ☐ Mortar ☐ Roots ☒ **Wall**

INFILTRATION @ BARREL WALL

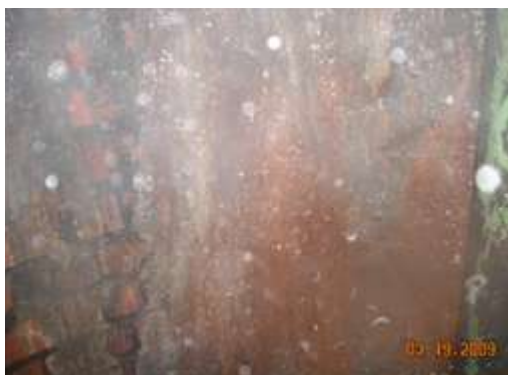
Defect 2

Condition: ☐ Sound ☐ Cracked ☐ Root Intrusion ☐ Loose Brick ☒ **Deteriorated**

ENCRUSTATION/DETERIORATION OF
BARREL WALL

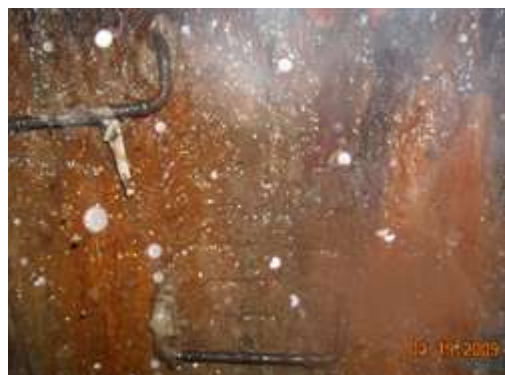
Defect 1

☒ **Evidence Of Surcharge**

SURCHARGE EVIDENCE

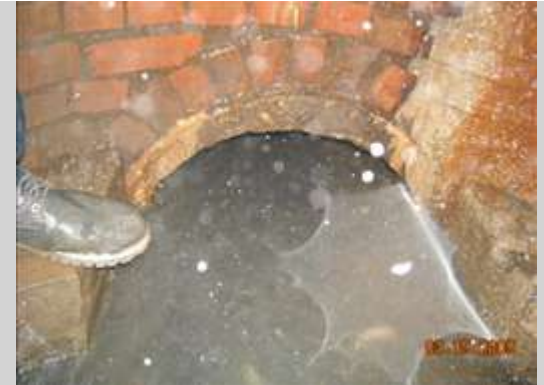
12 O'Clock Outflow

Pipe Height: **24** (in.) Rod and Bar (Angled)
Pipe Material: **Clay** ☐ Pipe Lined
Invert Depth: **21.65** (ft.) Flow Characteristics: **Slow**
Deposits: ☐ None ☒ **Mud** ☒ **Gravy** ☐ Debris ☐ Grease
Silt Depth: **8** (in.) Deposits Extent: **Medium**
Infiltration: **Evidence** Pipe Seal Cond: **Sound**

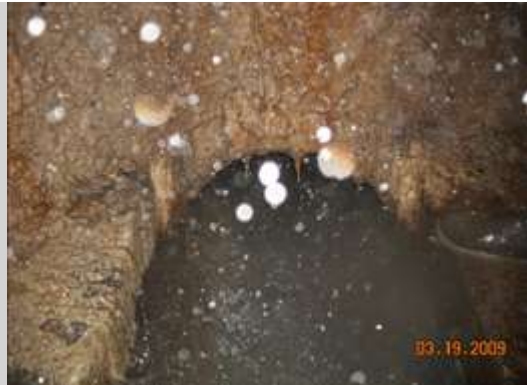
6 O'Clock Inflow

Deposits: ☐ None ☒ Mud ☒ Sludge ☐ Debris ☐ Grease

Silt Depth: **6** (in.) Deposits Extent: **Medium**

Infiltration: **Evidence** Pipe Seal Cond: **Unknown**

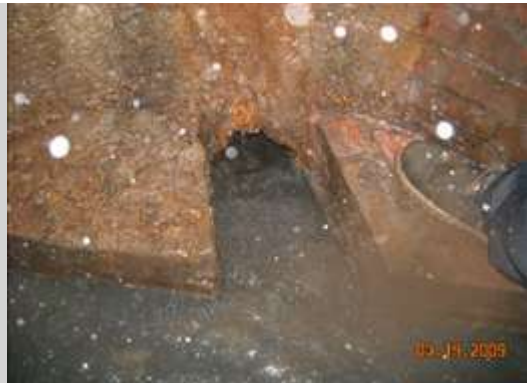
9 O'Clock Inflow

Deposits: ☐ None ☐ Mud ☒ Sludge ☐ Debris ☐ Grease

Silt Depth: **2** (in.) Deposits Extent: **Medium**

Infiltration: **Weeper** Pipe Seal Cond: **Unknown**
